Building Inspection Report

1234 Mountain Lion Ln., Manassas, Va.

Inspection Date:
2-27-06

Report Number:
155322706

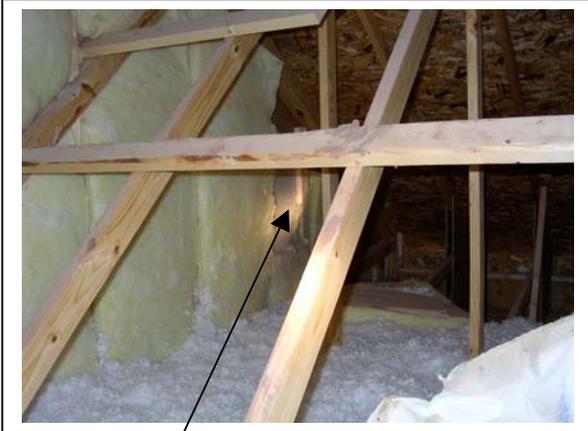
- **Improve:** Insulation has fallen at one area at the loft stairs. This is visible at the attic/kneewall access panel in the loft. Insulation also needs securing at the access panel itself.

Fallen insulation at loft stairs area.

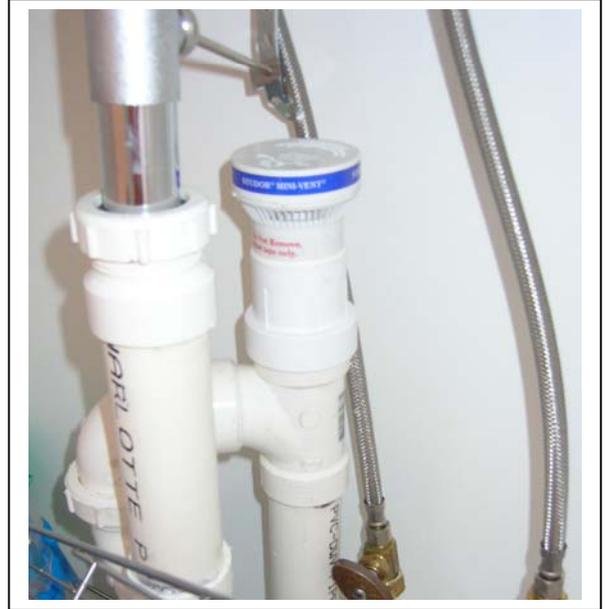
“Studor” type vents are in use in your plumbing drain system. These vents use a flap to allow air into the system when needed and are usually found under sinks. If sewer gas is ever smelled in the house, it is likely that one of these vents has failed and will need repair/replacement. The house may have a radon system in place based on the pipe (3 inch) found exiting the rear wall.

Mechanical vent at kitchen sink.

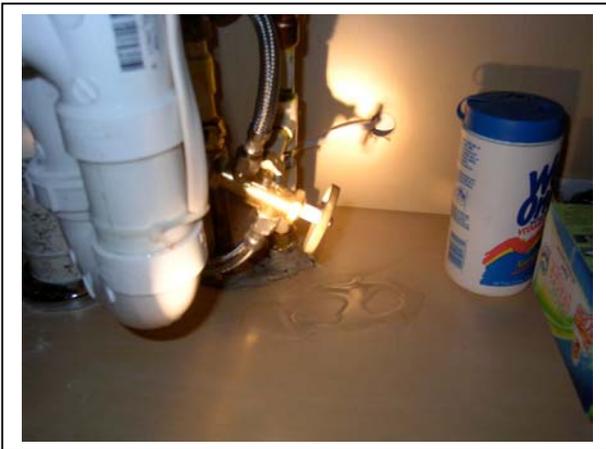
- **Repair:** A leak was found under the kitchen sink, though the cause is not known.

Leak under kitchen sink.

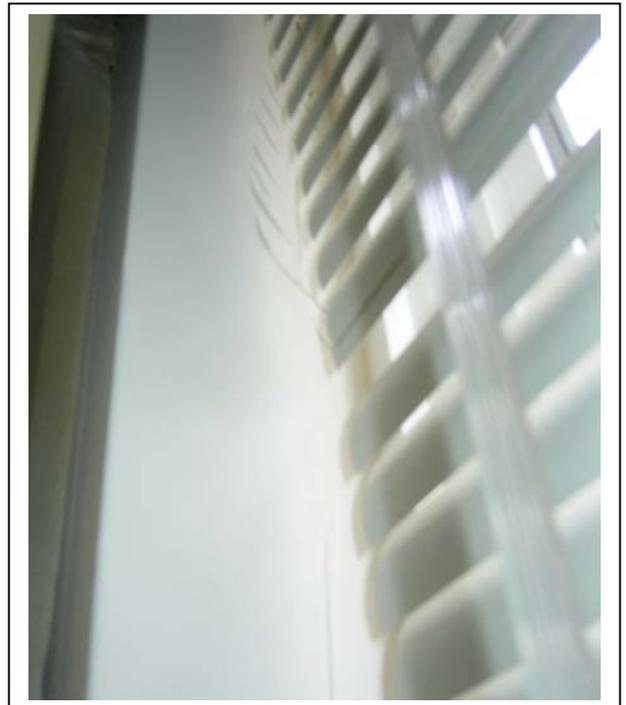
- **Monitor:** Water staining/peeling paint was observed at the side of the window of the family room at the side wall. Caulking may need improving. No active moisture was found.

Peeling paint/staining at family room window.

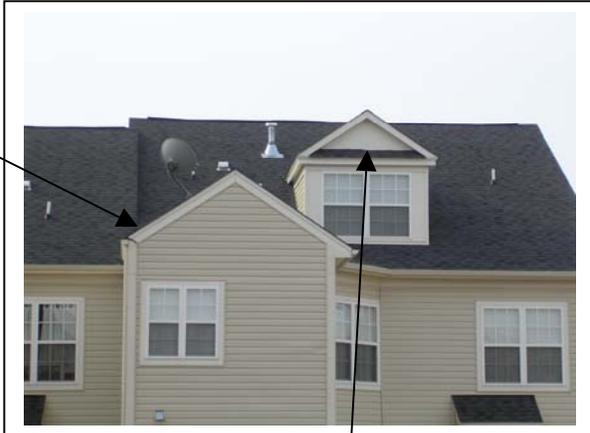
- **Monitor:** The flashing over the small roof at the rear of the house appears to have been caulked and may not have been properly installed. Also, the area where your roof and your neighbor's roof meet at the rear of the house may also be vulnerable. See pictures.

Potential vulnerable areas at rear roof.

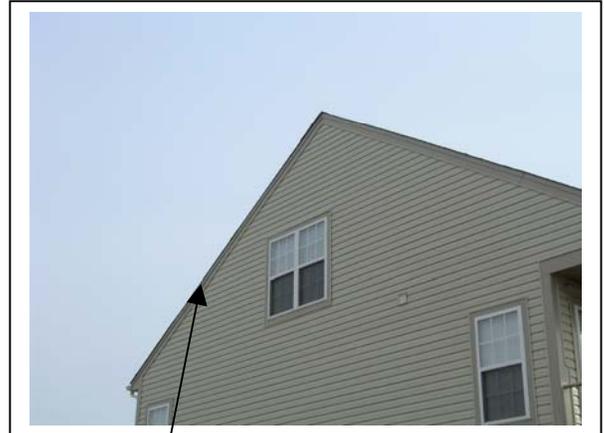
- **Improve:** Caulking is needed at trim joints to keep water out. This includes trim at the roofline.

Roof trim needs caulking.

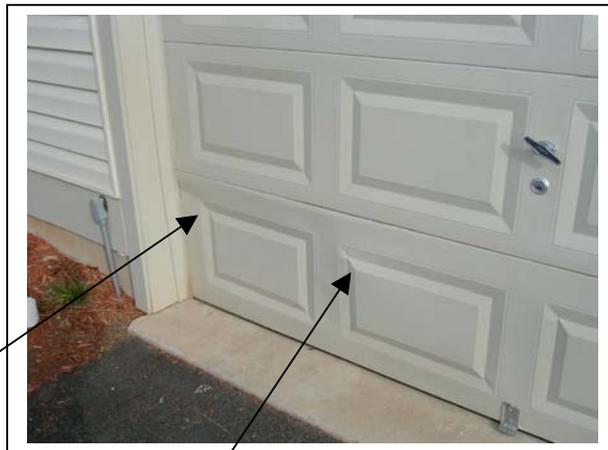
- **Monitor: Repair:** The overhead garage door is damaged along the bottom and may need repair. It is also difficult to open. It appears to have been hit from the inside.

Damage at garage door.
